Operation TEAPOT

Project 31.2

DAMAGE TO COMMERCIAL AND INDUSTRIAL BUILDINGS
EXPOSED TO NUCLEAR EFFECTS

Bruce G. Johnston

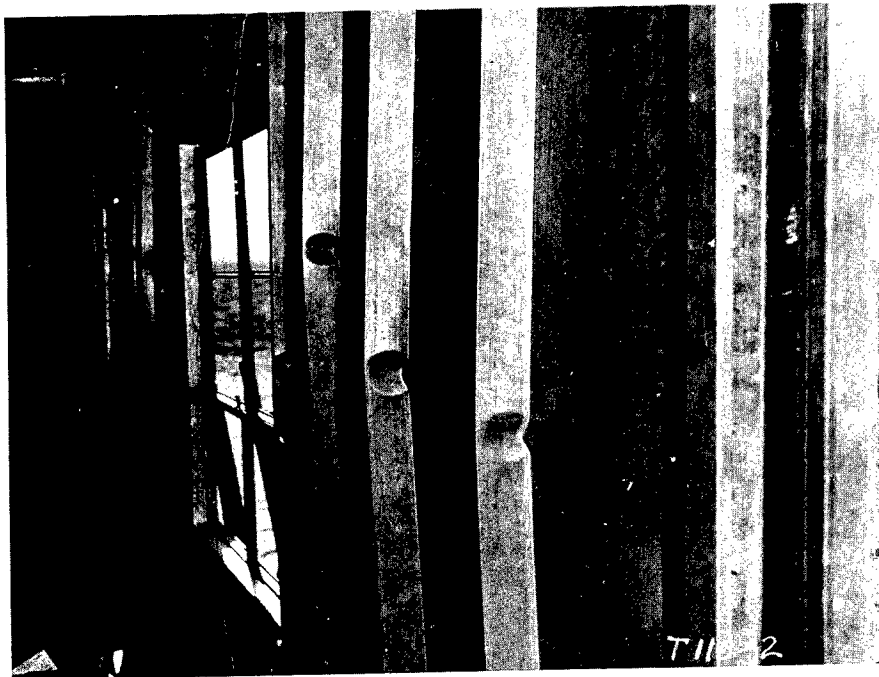
Fig. 2.8 — Interior view of damage to north wall of Armco Building 31.2-d1 from unexpected test.

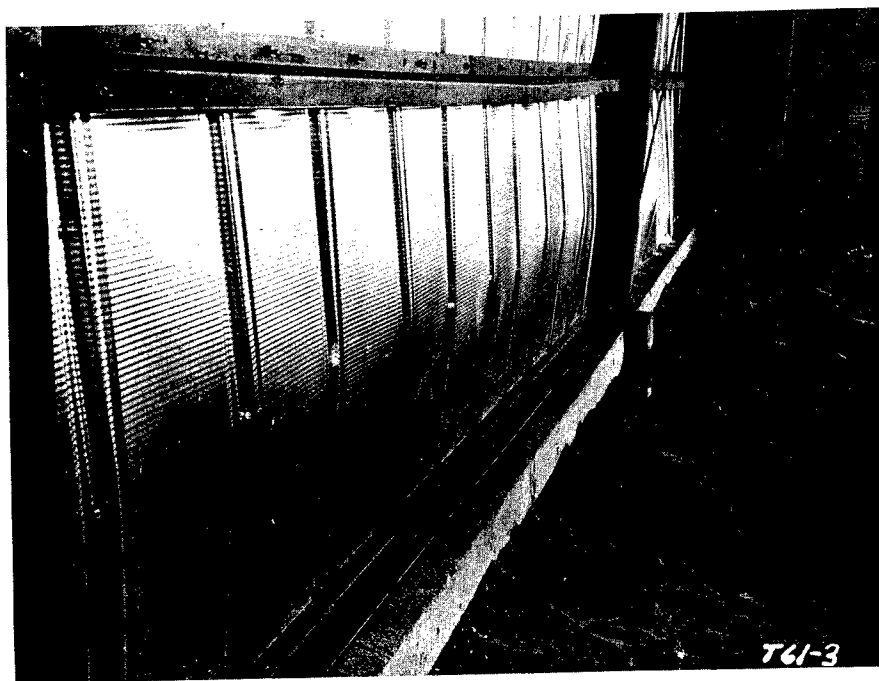
Fig. 2.9 — Interior view of wall damage in Reynolds-Butler Building 31.2-a2 from unexpected test.

The roof sheeting on Reynolds-Butler Building 31.2-a2 had not been placed, and the blast caused movement of both walls away from the blast origin, damaging both paneling and girts to a very minor extent. Deflections of the wall paneling on the north side amounted to as much as 2 in. in the lowest space, as shown in the interior view (Fig. 2.9). Washers had been installed properly with all bolts, and no bolts pulled through the sheeting on the north face, although two bolts with washers did pull through the south face sheeting due to the negative aspect of the behavior with an open roof.

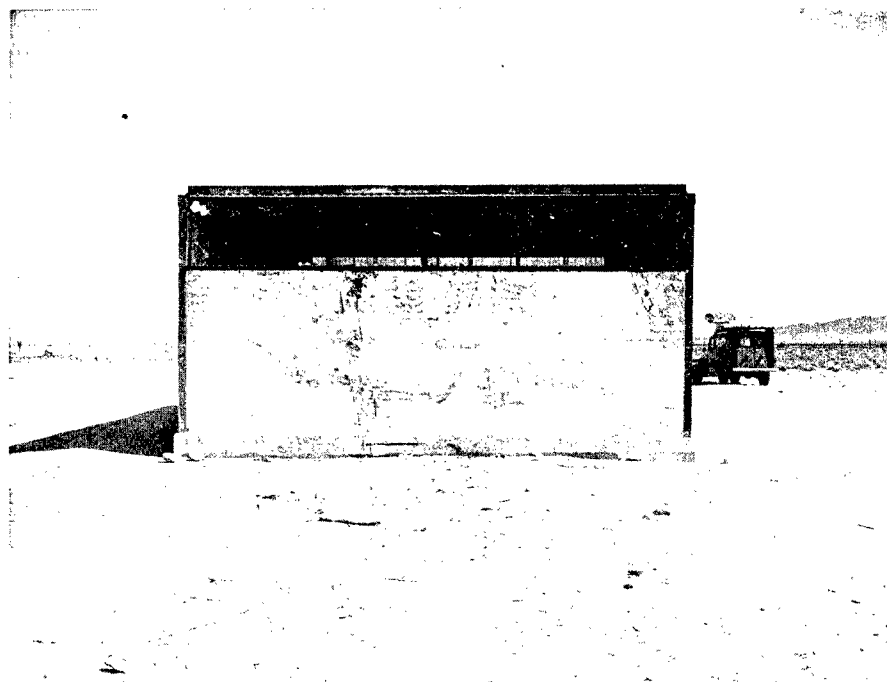
The trajectory of the window pieces from the north wall appeared to be downward. Although there were indications that small particles had struck the south wall window, most

Fig. 2.10—North wall of Union Carbide building after planned test.

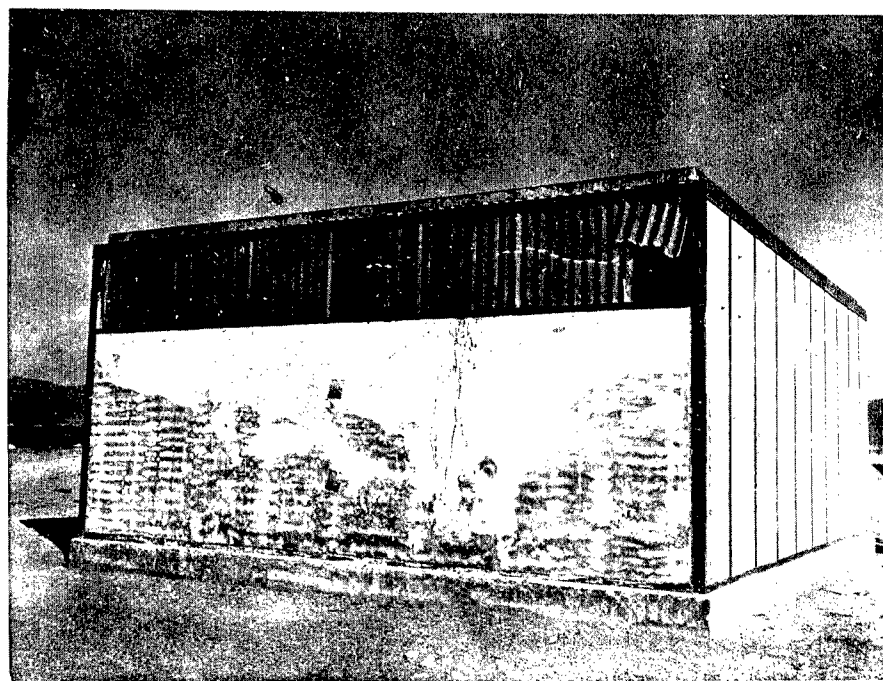
Fig. 2.11—South wall of Union Carbide building after planned test.

marks were made on the gypsum portion of the south wall. The portion of the south window that was broken outward could have been damaged by a piece of the north window. The marks left by the plastic pieces were not sharp and penetrating.

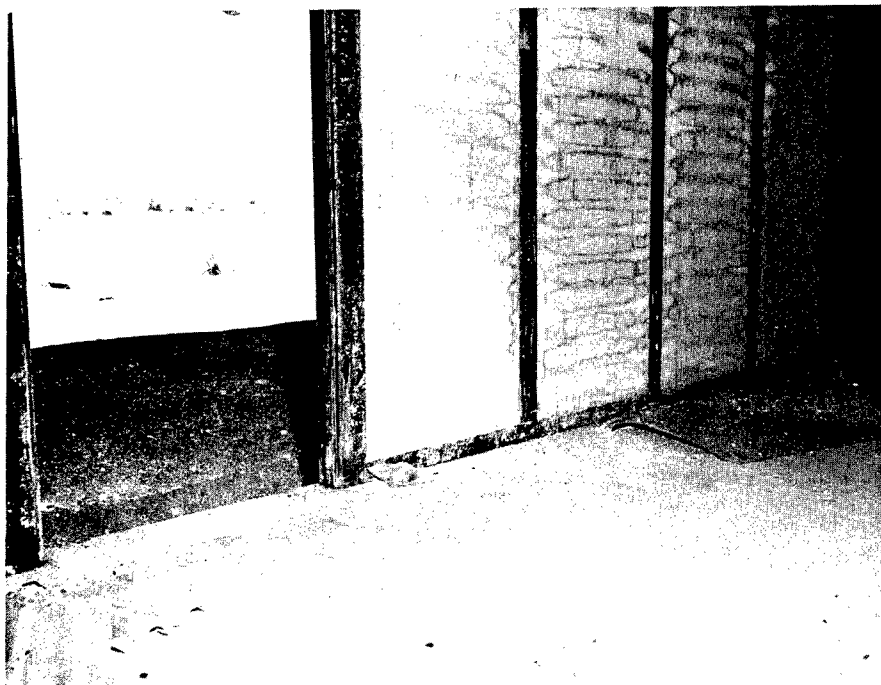
Fig. 2.12—Interior view looking out doorway of Union Carbide building after planned test.

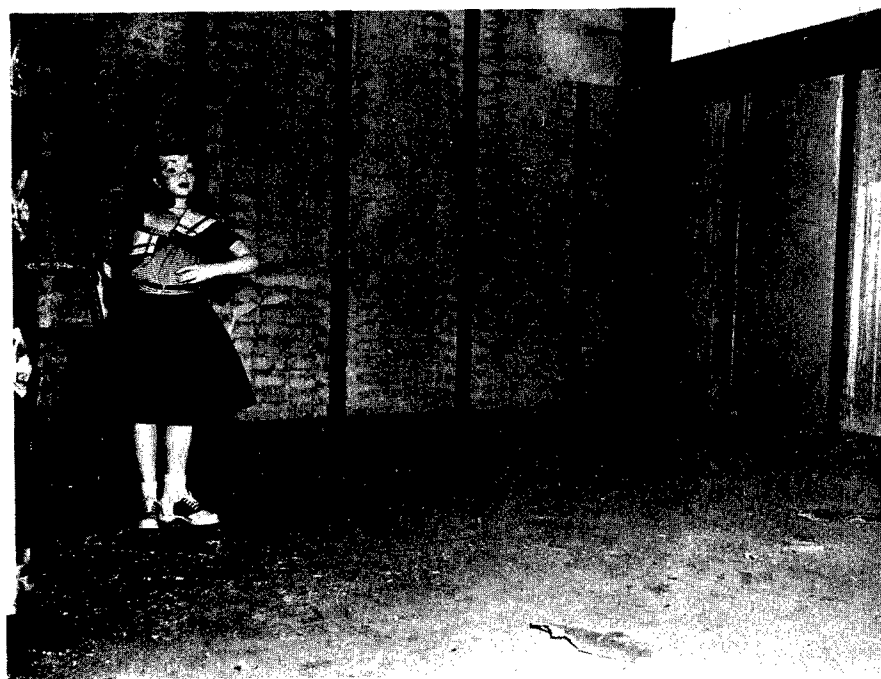
Fig. 2.13—Interior view of southeast corner of Union Carbide building after planned test.

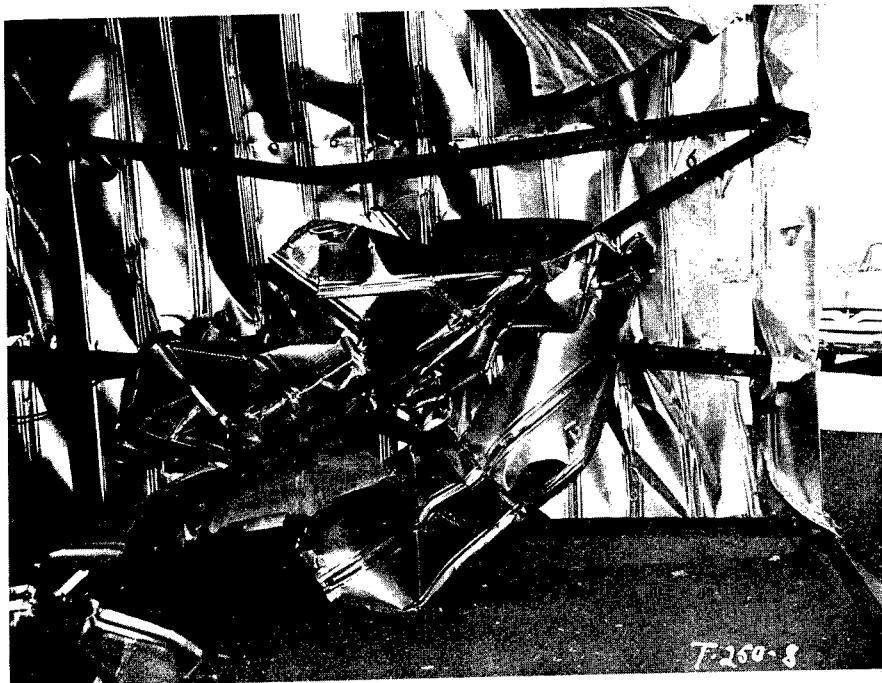
Fig. 2.22 — Interior view of Reynolds-Butler Building 31.2-a1 after planned test. (Note that west girts and panels of north wall have been thrown against west end.)

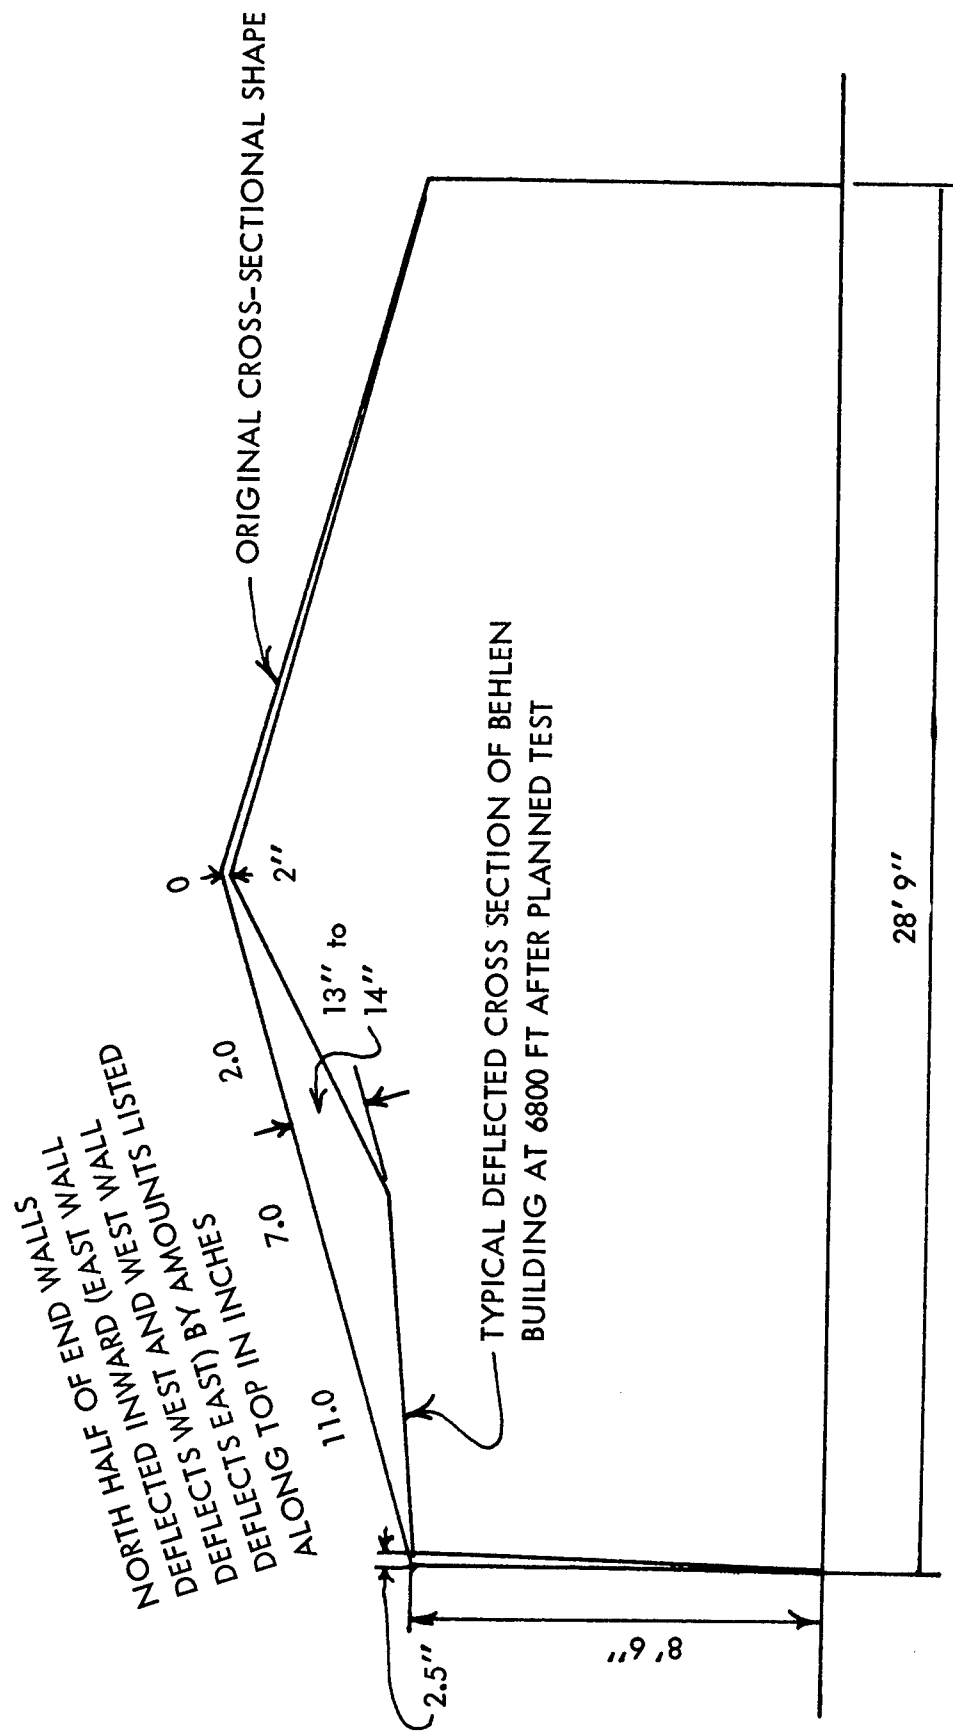
Fig. 2.33 — Permanent deflection of Behlen Building 31.2-b1 at 6800 ft after planned test.

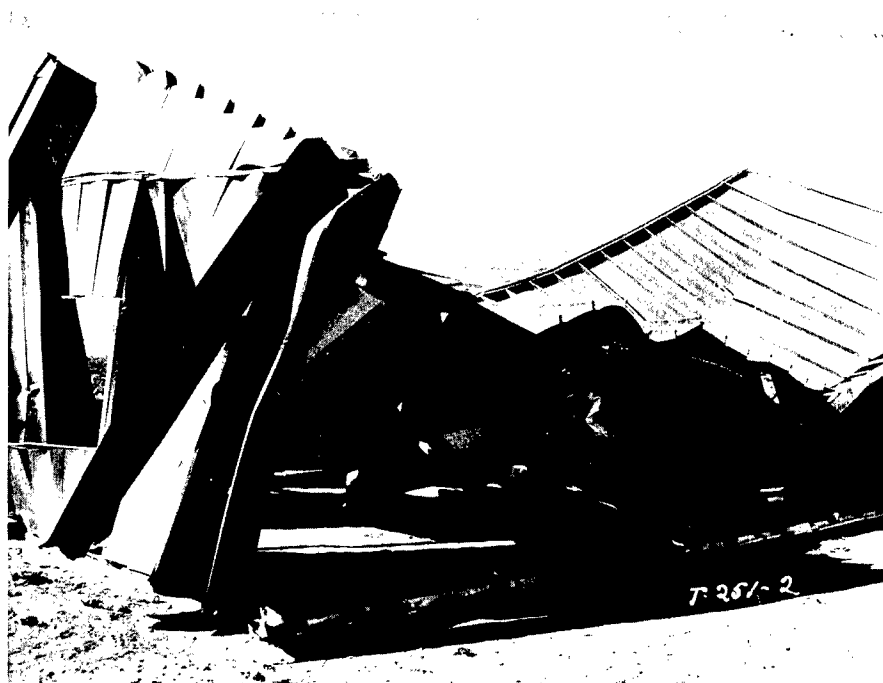
Fig. 2.39 — Northeast corner of Armco Building 31.2-d1 after planned test.

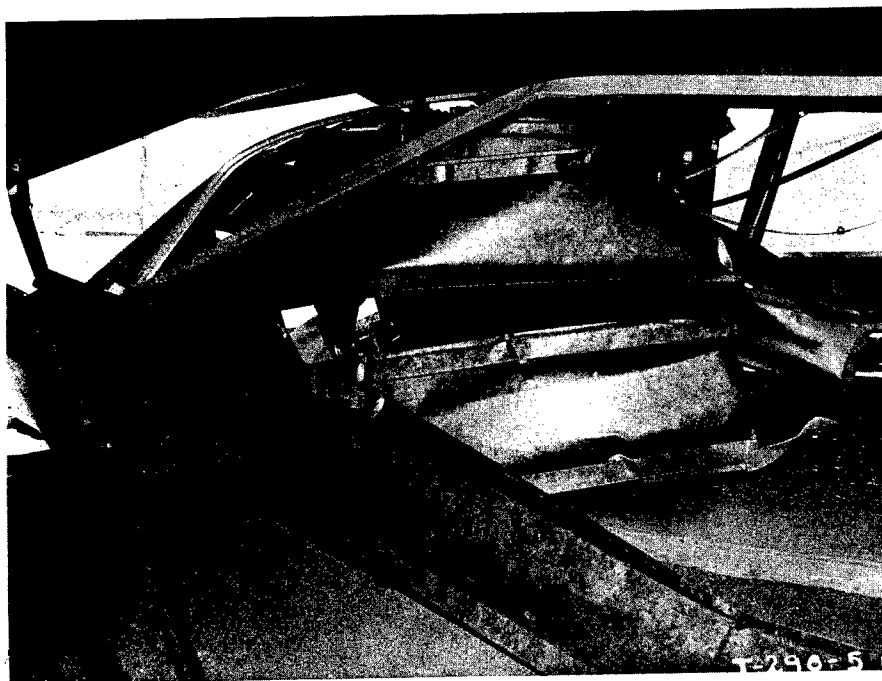
Fig. 2.45—Interior view of Armco Building 31.2-d1, showing front paneling draped around machinery after planned test.

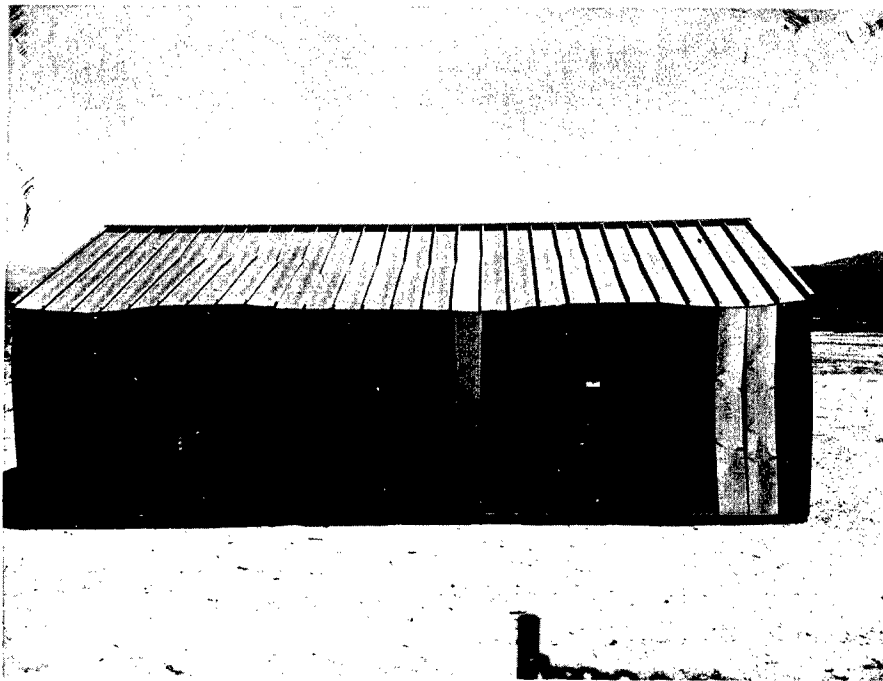
Fig. 2.51 — North side of Armco Building 31.2-d2 after planned test.
